**Docket No. 217 – Development and Management Plan Inspection**

Northeast Utilities Service Company Certificate of Environmental Compatibility and Public Need for the construction of a 345-kV electric transmission line and reconstruction of an existing 115-kV electric transmission line between Connecticut Light and Power Company's Plumtree Substation in Bethel, through the towns of Redding, Weston, and Wilton, and to the Norwalk Substation in Norwalk, Connecticut.

**Norwalk Substation**

**Date:** April 12, 2006

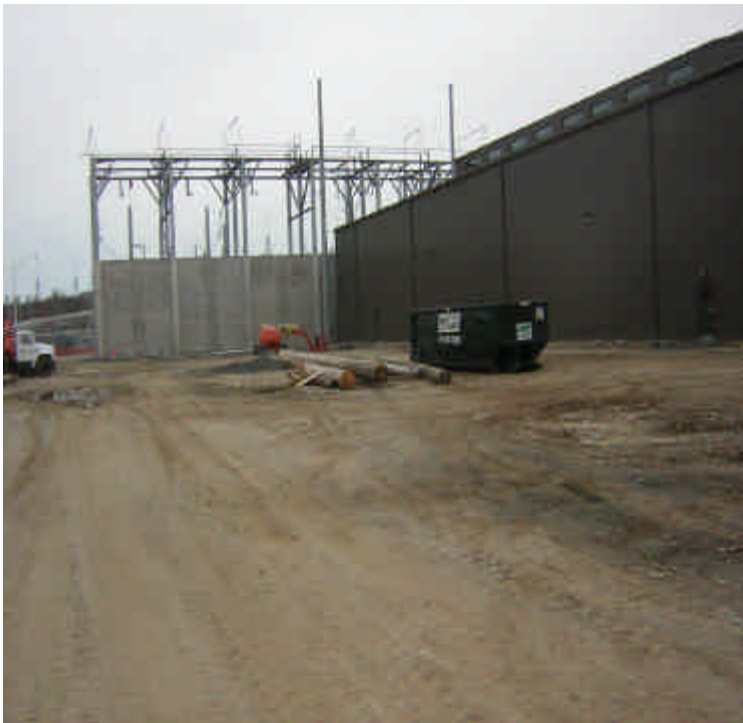
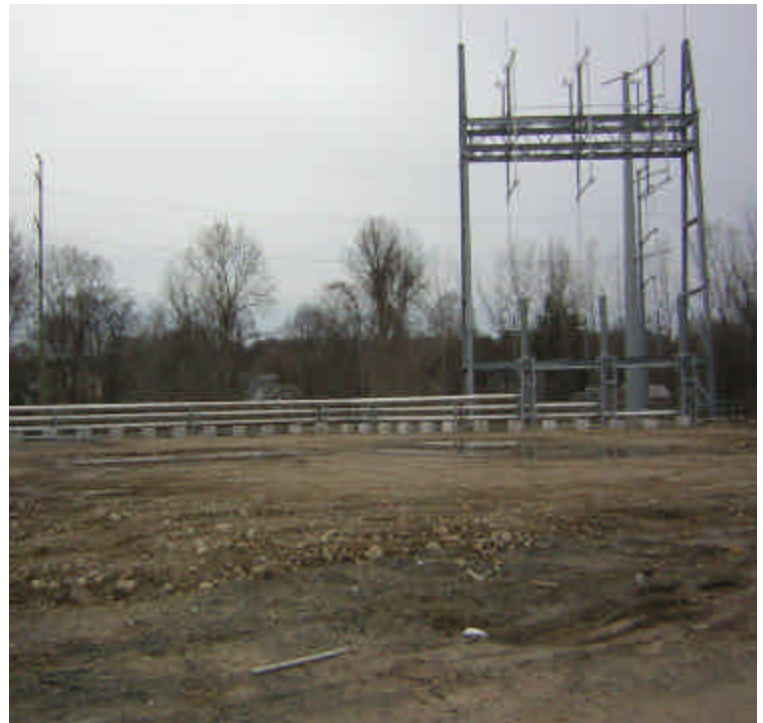
**Norwalk Substation:** Both photos show views of the general site condition of the yard near the GIS building. Most materials have been cleaned up and removed. 4/12/06.

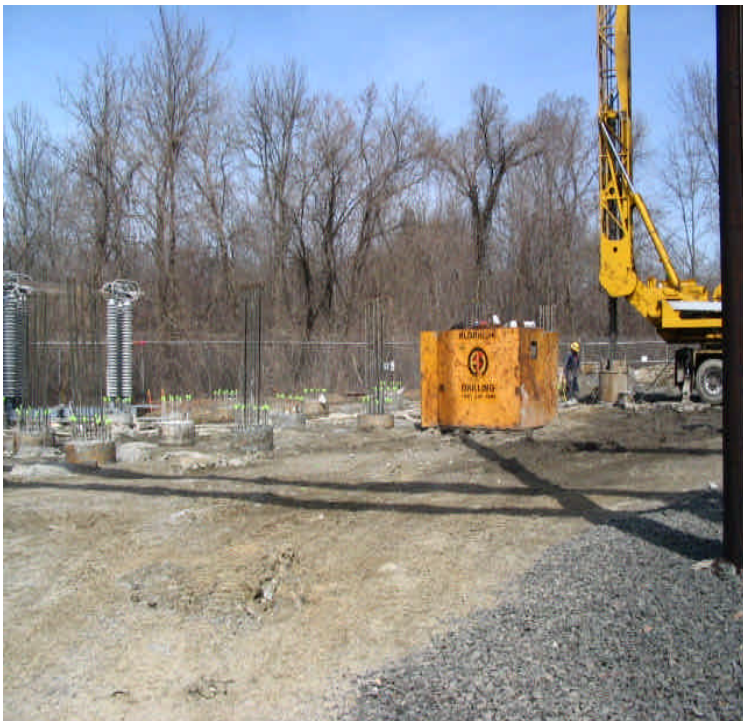
**Plumtree Substation:** Photo on the left shows work continuing within the substation yard with some foundation work and caisson drilling. Photo on the right shows a stockpile placed along the perimeter fence. Haybales have been placed at the base of the pile, along the perimeter fence. 4/12/06.
